MX-5 Protecting the bottom

Graham Keates shares with us his experience of protecting his car from the threat of rust.

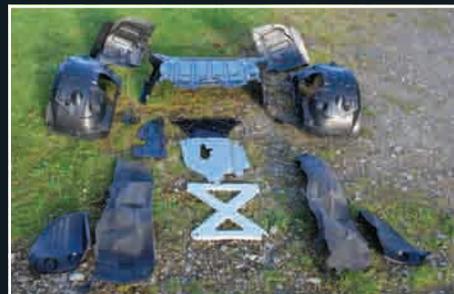
Stripped items

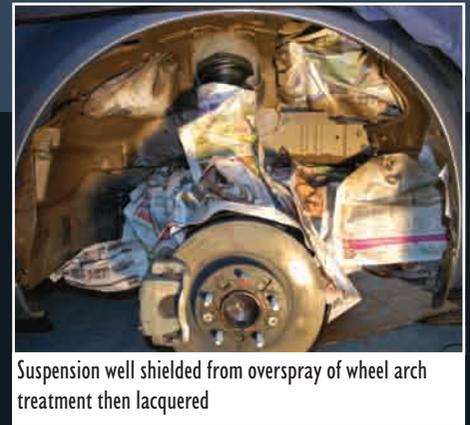
Suspension well shielded from overspray of wheel arch treatment then lacquered

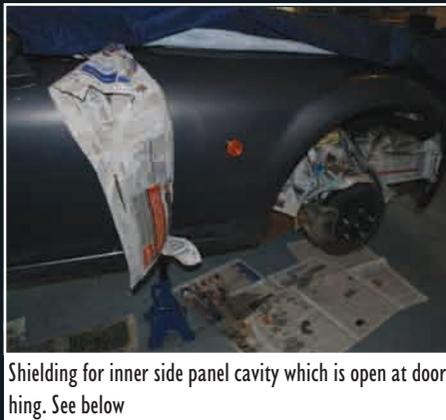
Shielding for inner side panel cavity which is open at door hing. See below

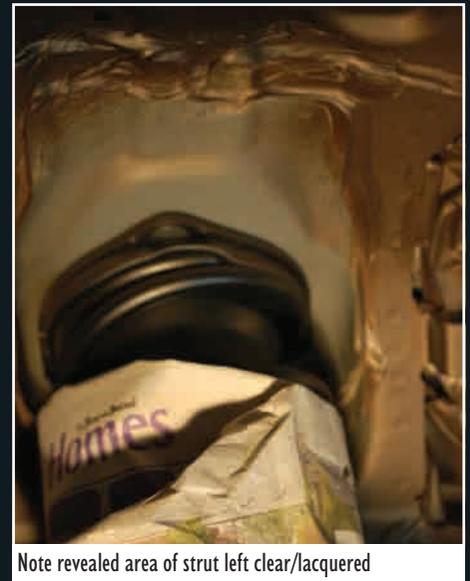
Note revealed area of strut left clear/lacquered

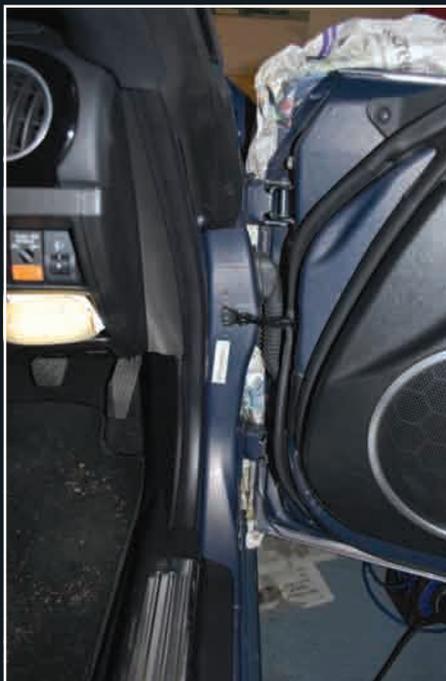
Blanking and final preparation then treatment

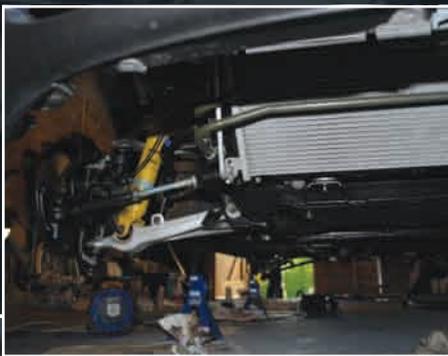
All underbelly lacquered

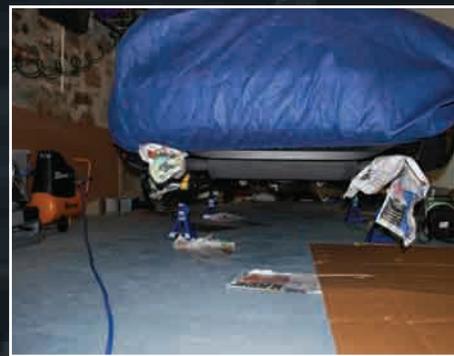
Exhaust painted black

Additionally, I painted the rear exhaust box with black manifold paint as well as the hub area and rims of all the brake discs.

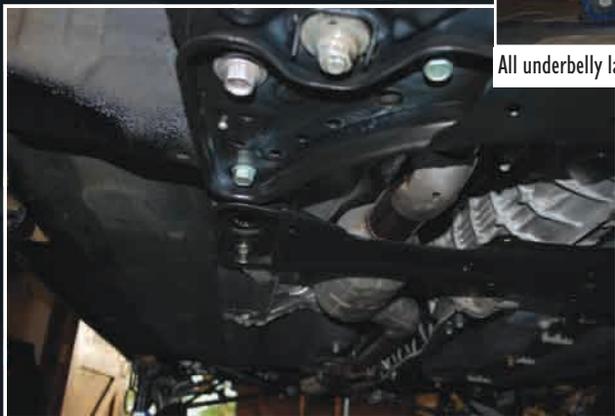
Only evidence of treatment visible on front crossmember
